BEDFORD FIRE HEADQUARTERS BUILDING SPACE UTILIZATION ASSESSMENT STUDY

*A Report to: Town of Bedford
December 7, 2015*

Prepared by: **CDR Maguire Inc.**
2 Granite Avenue, Suite 150
Milton, MA 02186

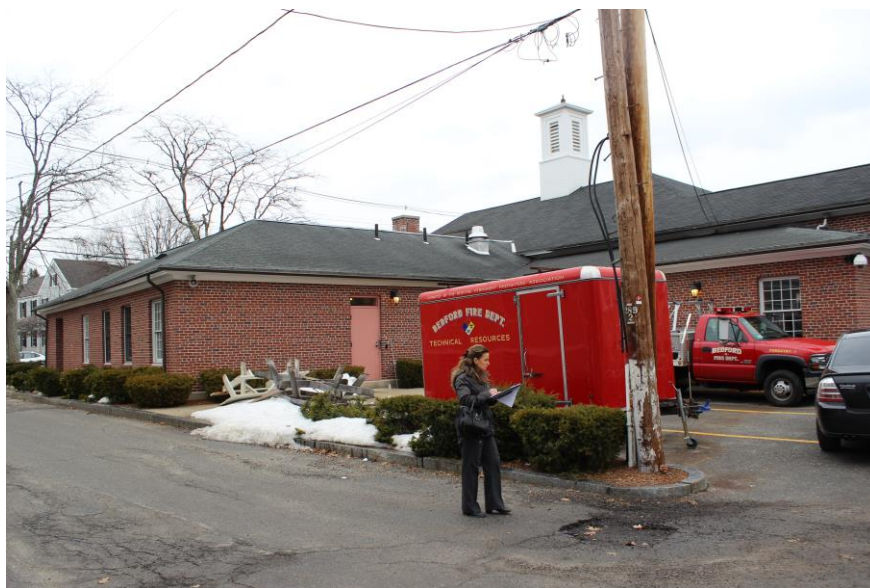
Figure 2 – Rear of facility with parking spaces occupied by fire apparatus and trailer

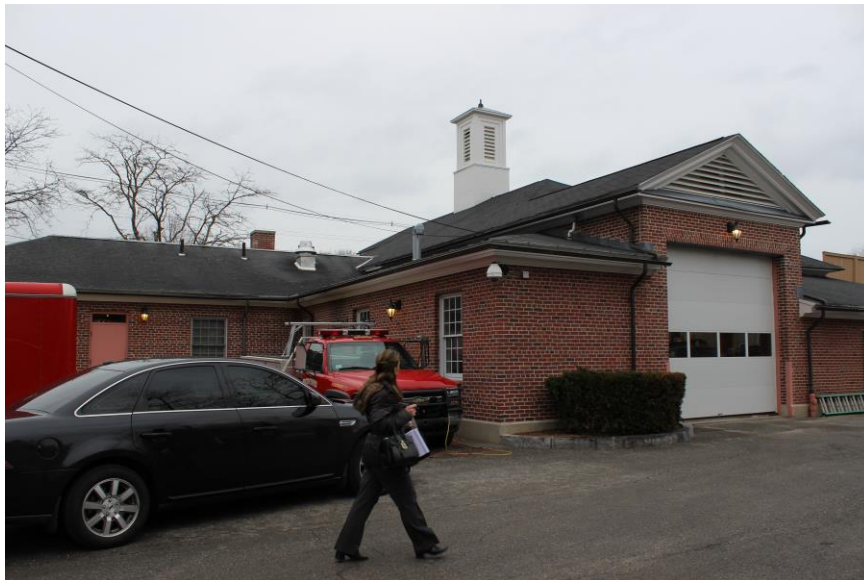
Figure 4 –Rear facing apparatus bay utilized by Squad truck. Due to depth of rear apron vehicle need to perform numerous maneuvers to exit on to Great Road

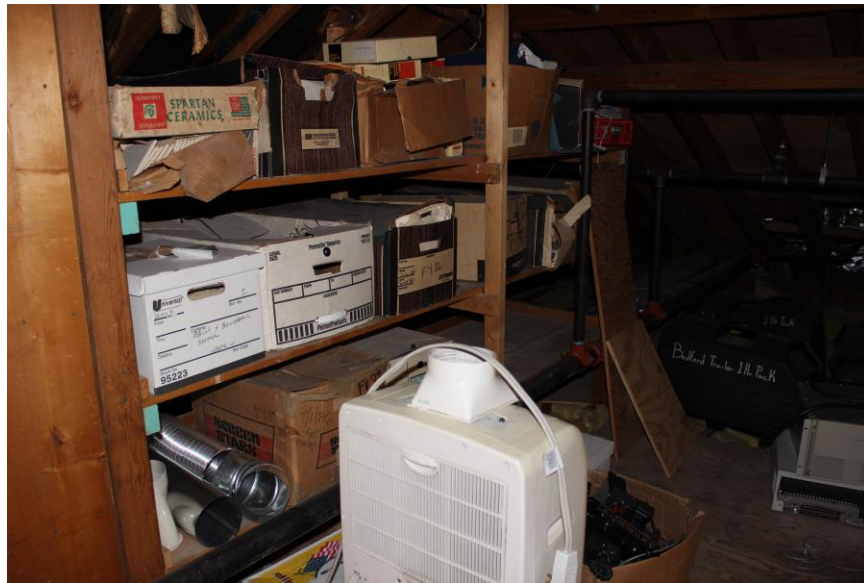
Figure 11 – File storage in attic

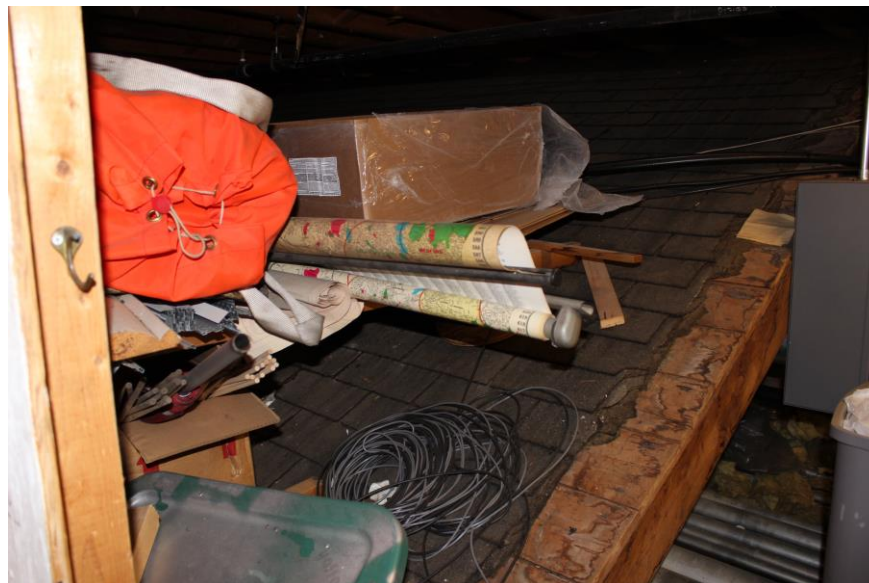
Figure 12– Storage in attic

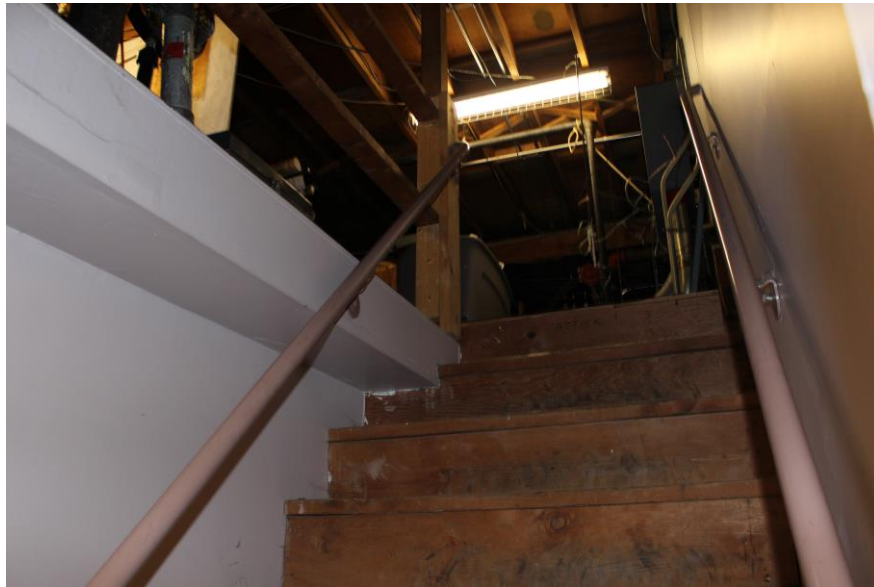
Figure 13 – Non-code compliant stair to attic

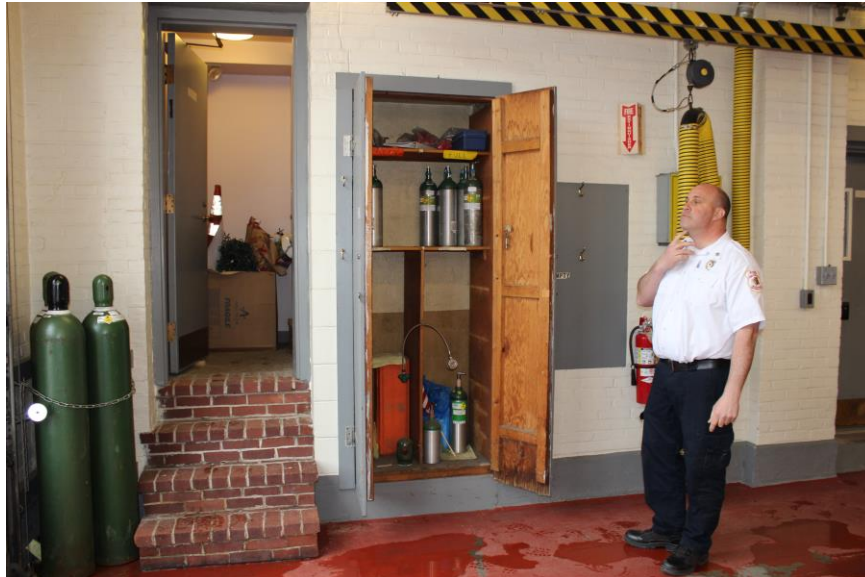
Figure 14 – Non-compliant steps, oxygen storage and storage of main oxygen tanks

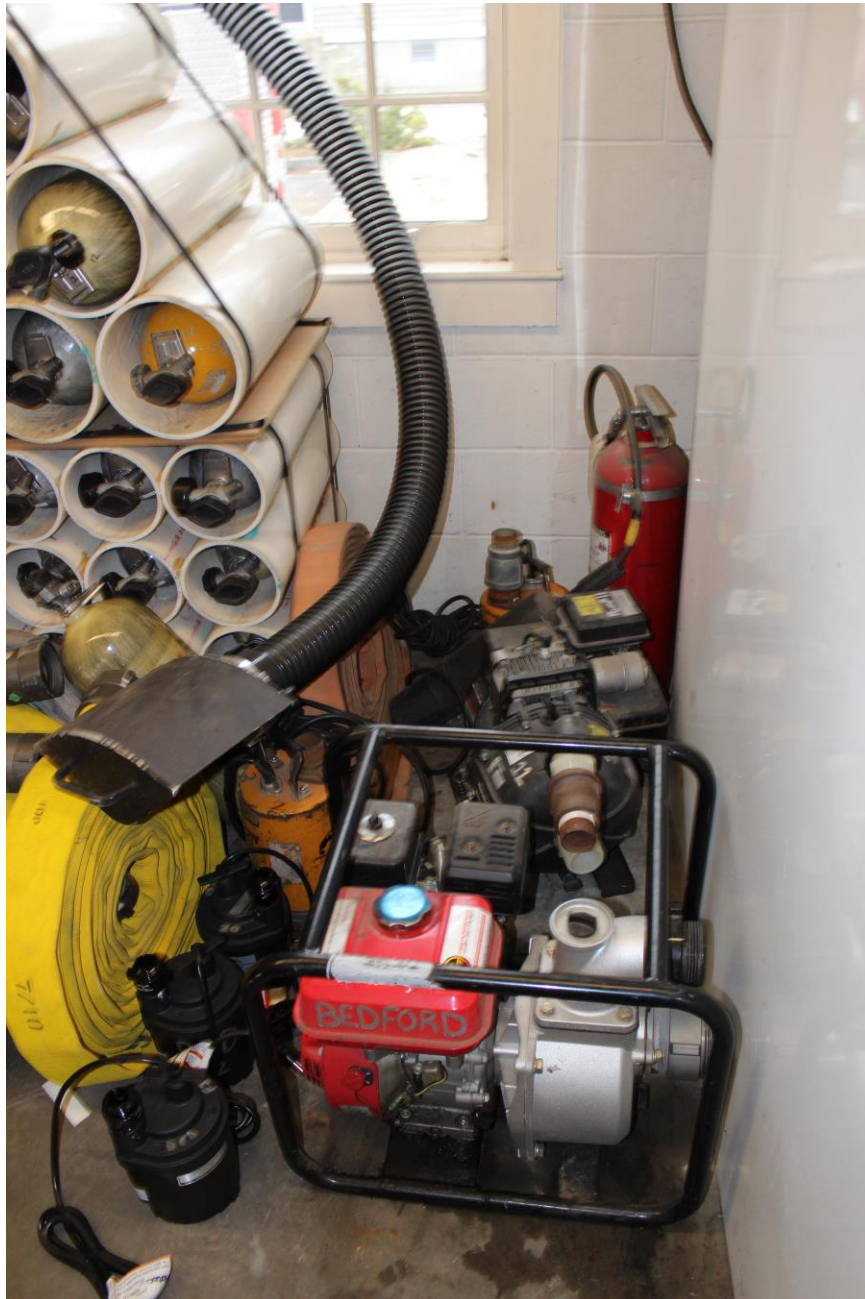
Figure 16 – Misc storage for SCBA tanks, generators, water pumps and hose

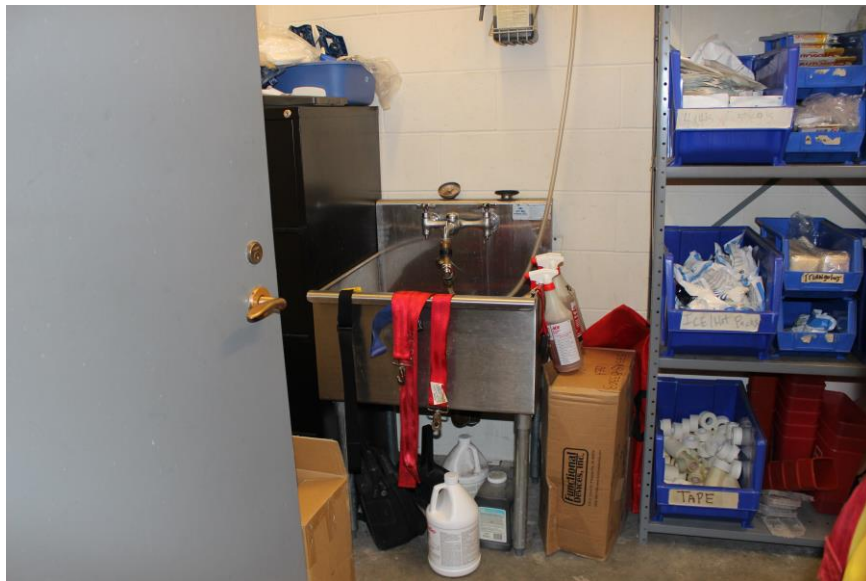
Figure 18 – Decontamination cleaning sink and strap drying within EMS storage area

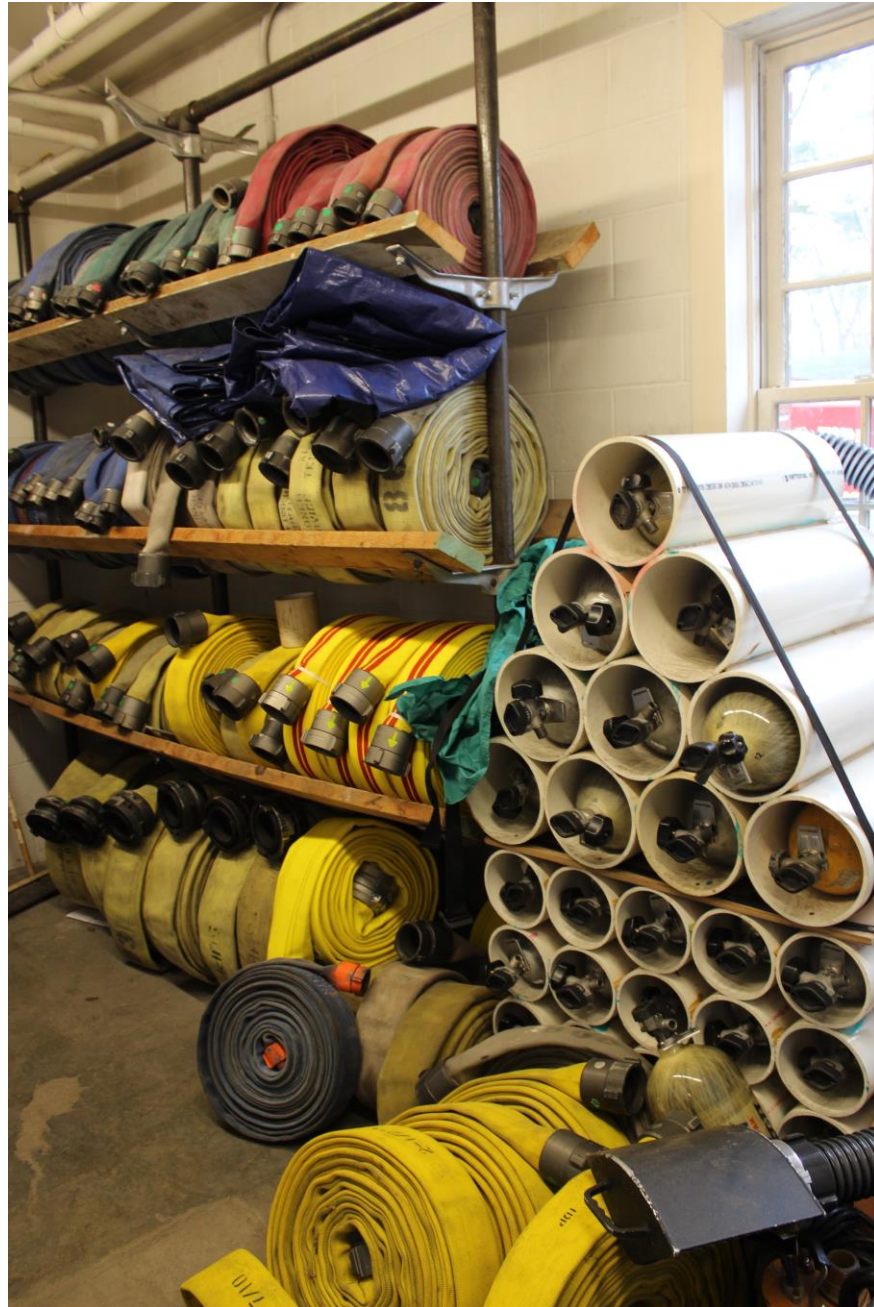
Figure 20 – Hose storage room, also used for filling and storage of SCBA tanks

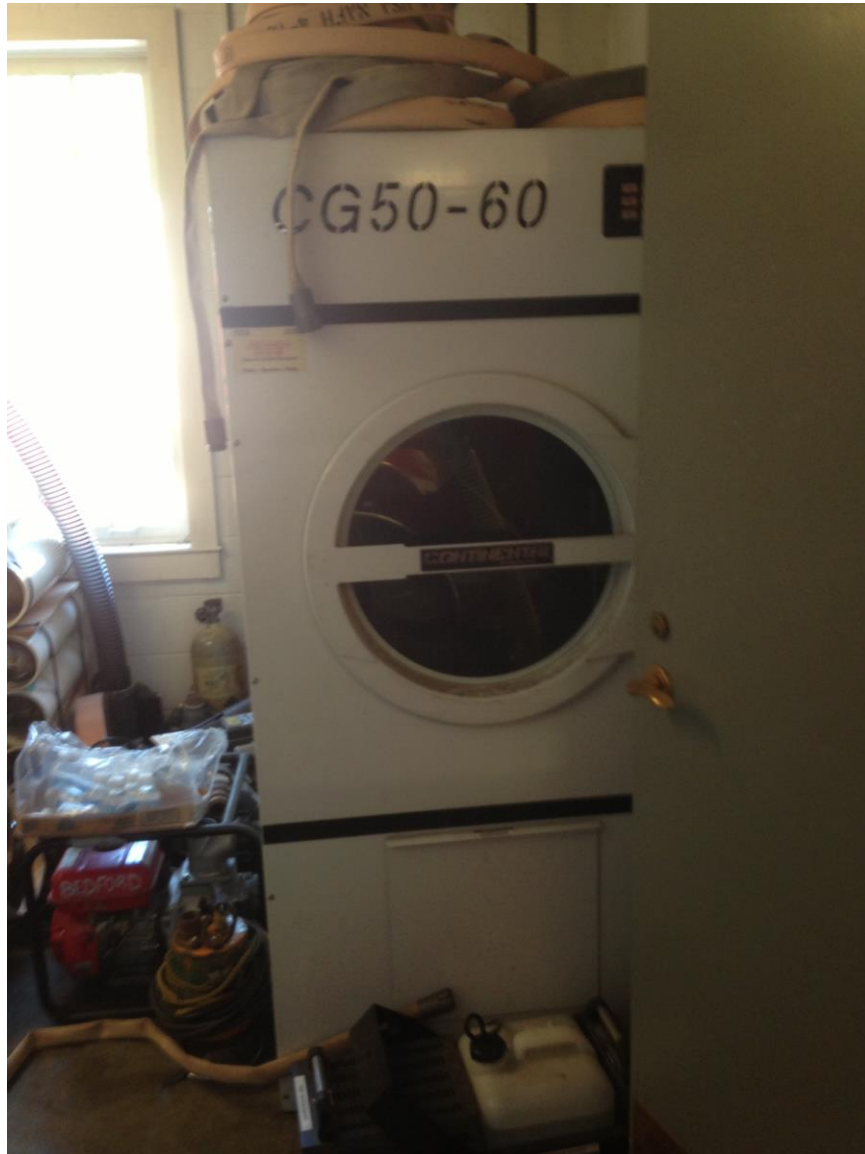
Figure 21 – Gear dryer located in hose storage room, also used for filling and storage of SCBA tanks

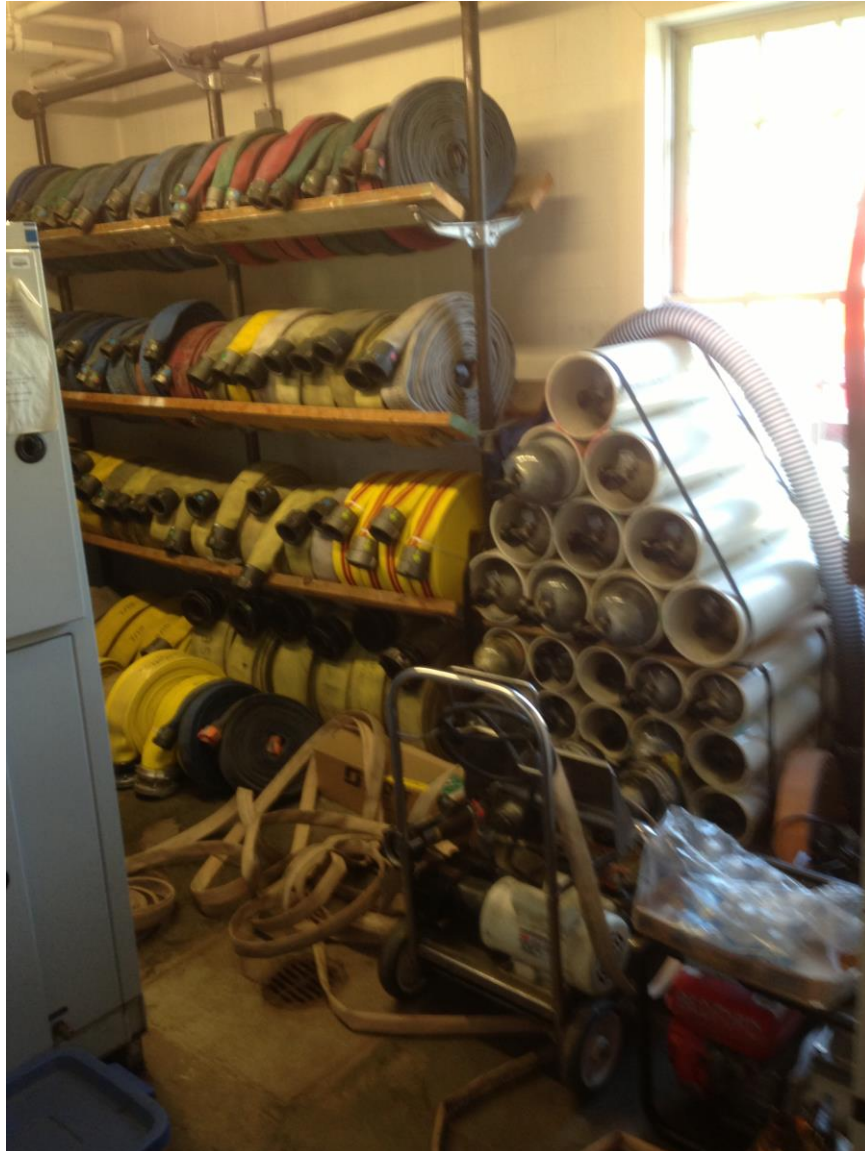
Figure 22 – Gear dryer located in hose storage room, also used for filling and storage of SCBA tanks

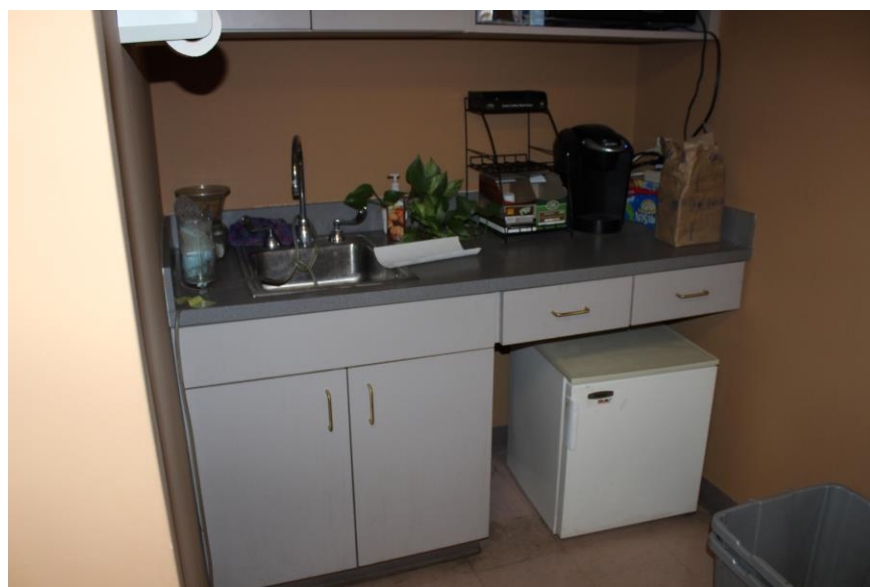
Figure 27 – Non-accessible administrative kitchenette

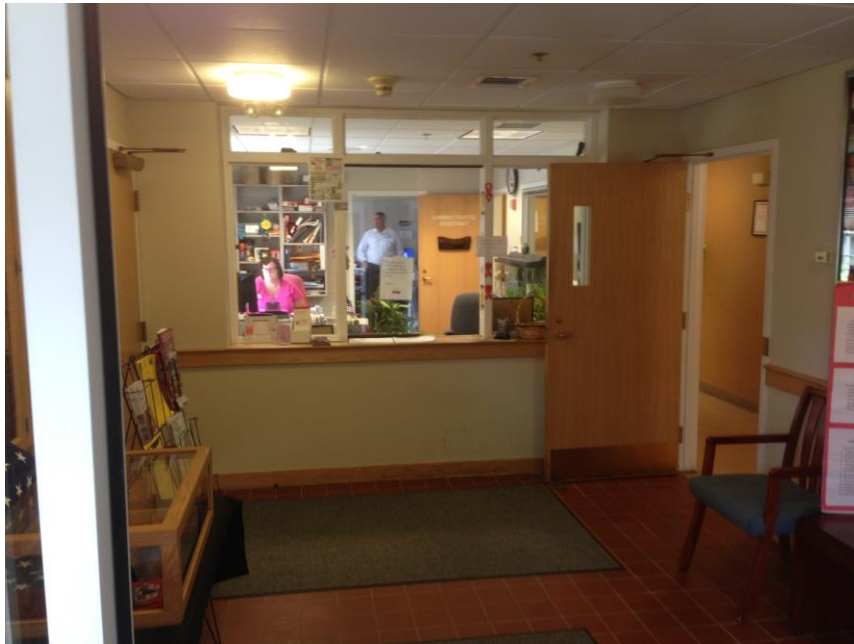
Figure 30 – Direct view form front vestibule through reception area into the Fire Chief's office

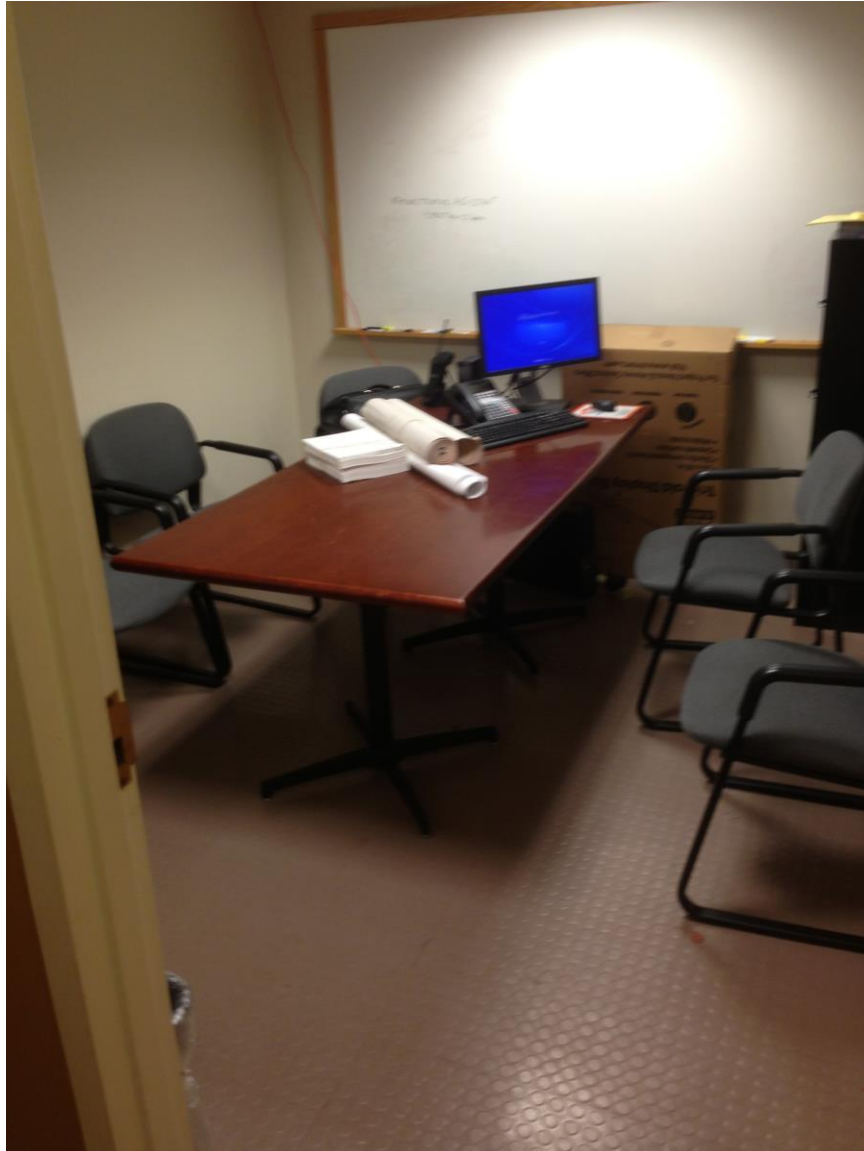
Figure 31 – First floor office used for conference room, plan review area and misc storage

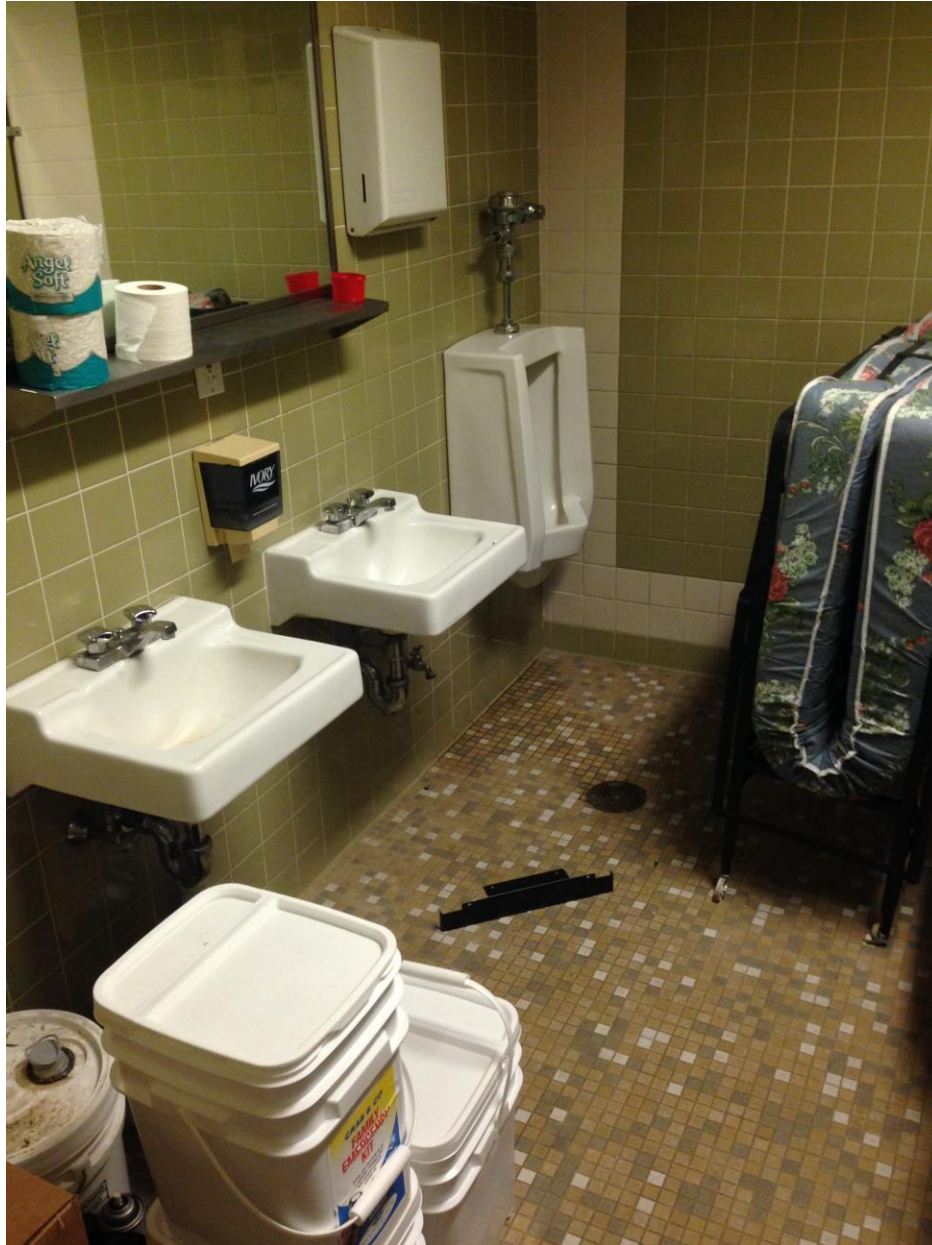
Figure 32 – basement toilet room used for storage

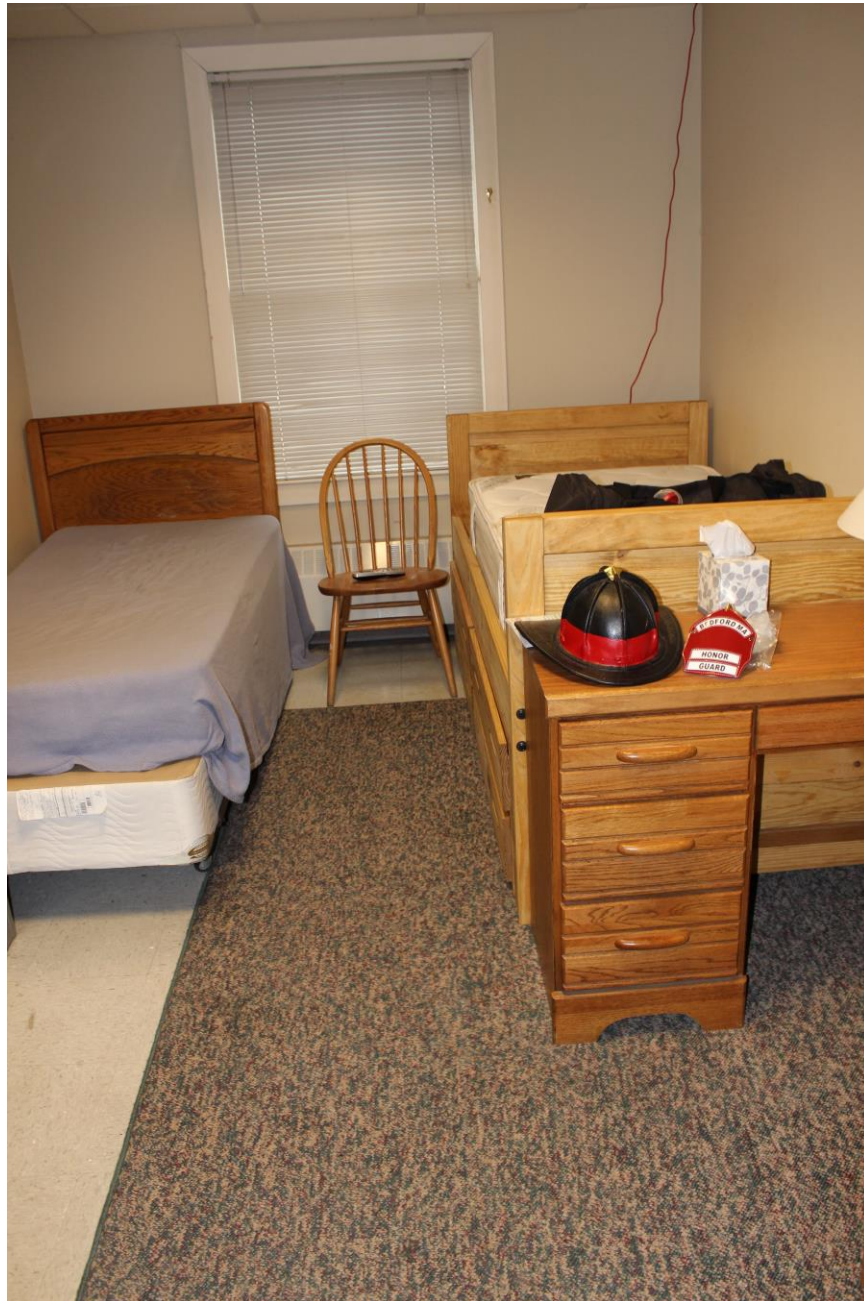
The firefighter living quarters are located on the west side of the apparatus bay. It consists of an open plan for the dining, kitchen, and day room as well as four bunk rooms. Two of the bunk rooms were originally designed as double occupancy but not used as such until the staffing increase of 2000 and 2015. Once the additional beds were added in 2000 it was noted that the space between the beds is less than 28". This is extremely tight, especially when both occupants are getting dressed to respond to a call.

Figure 35 – Typical layout of shared bunk room

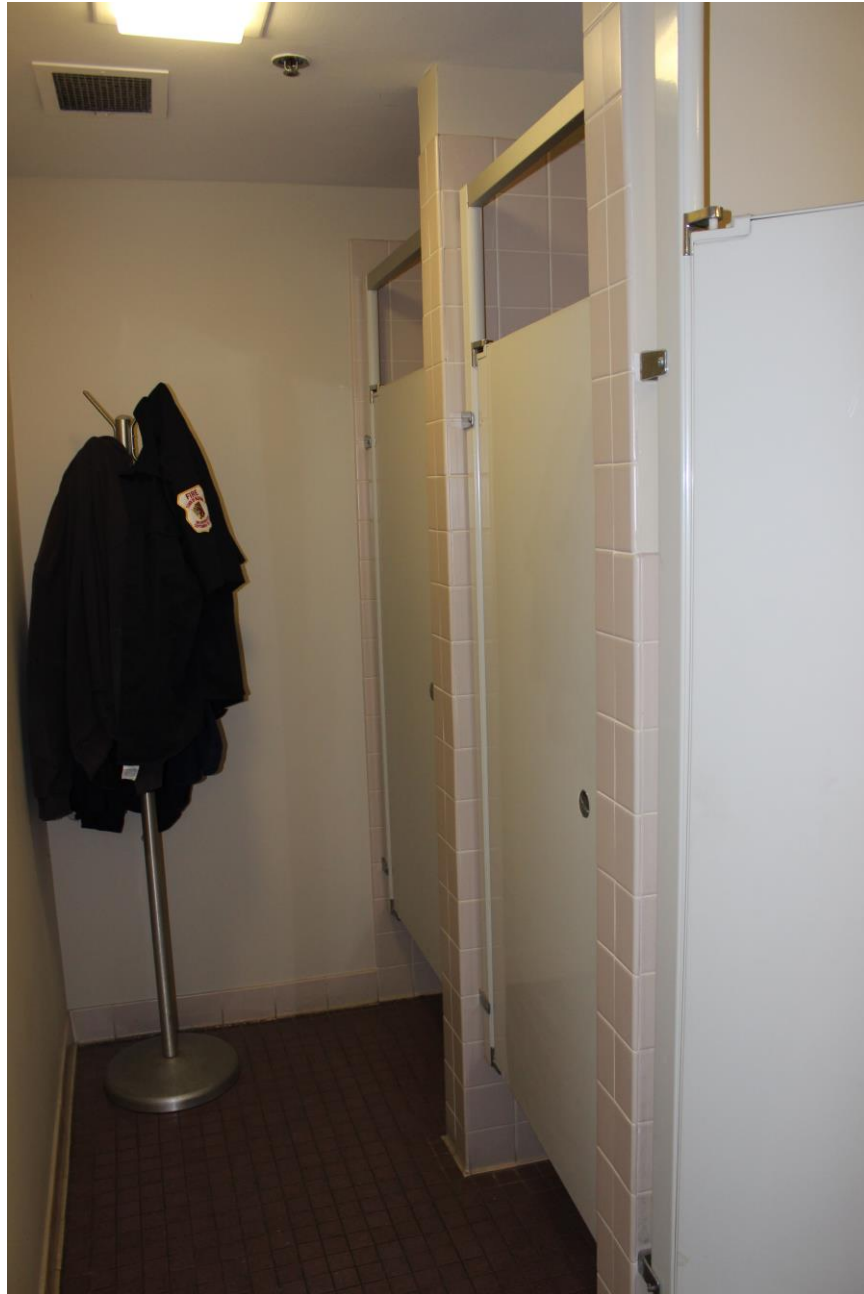
Figure 37 – Existing male shower and toilet stalls

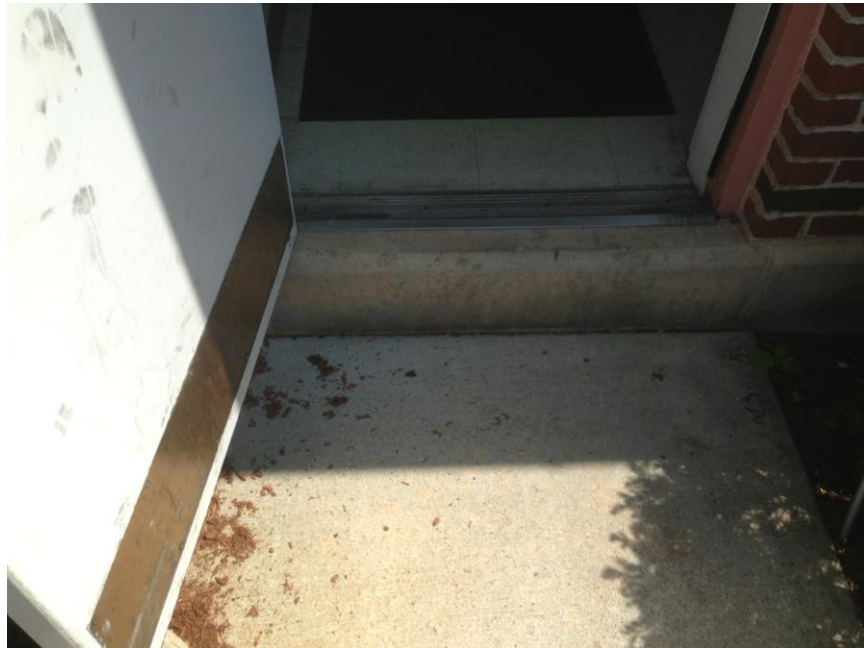
Figure 39 – Step at exterior door

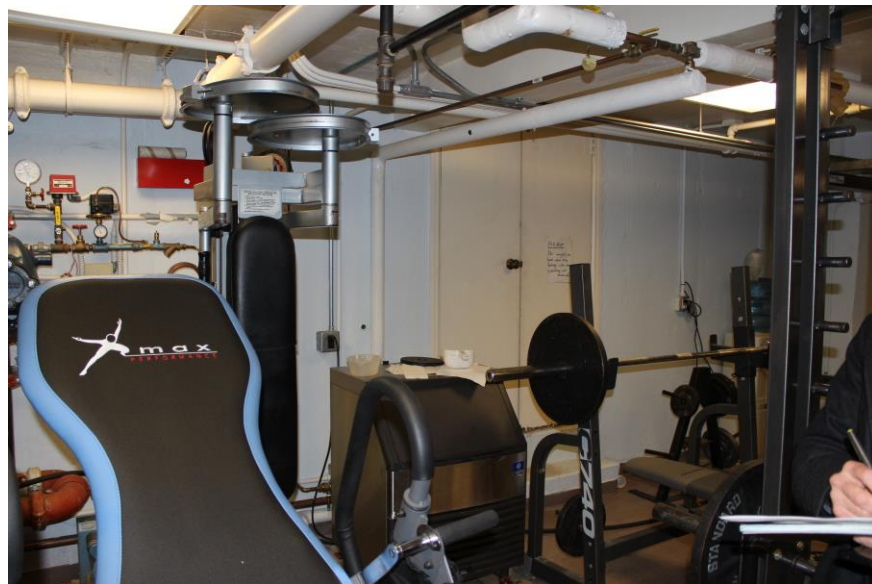
Figure 44 – Low ceiling in basement fitness room

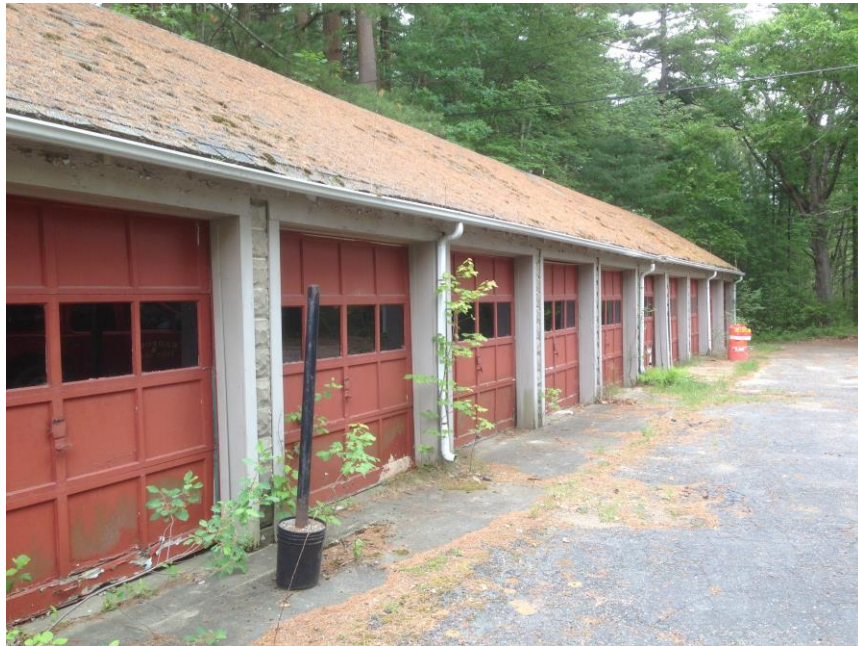
Figure 52 – Misc Town owned storage facility near the VA Hospital

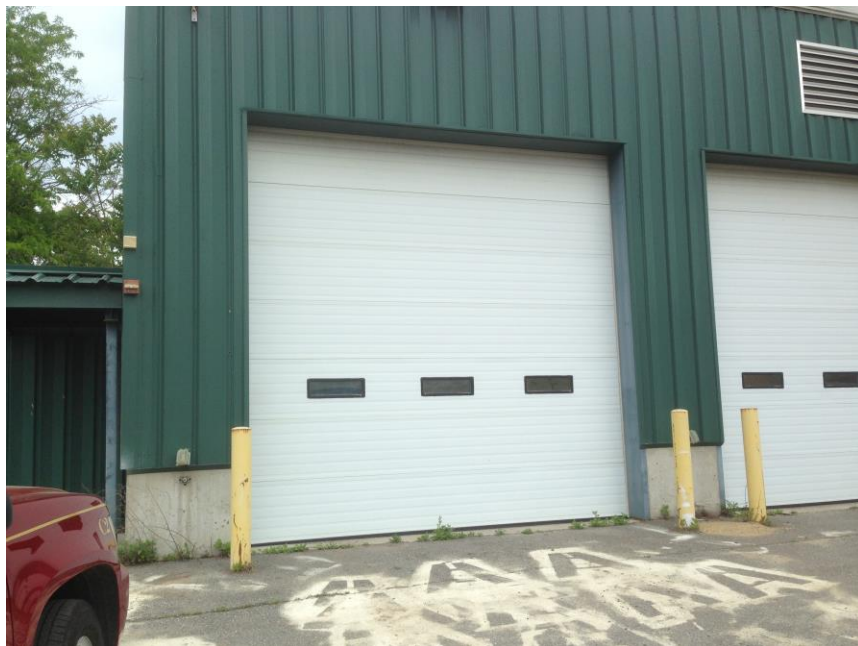
Figure 53 – DPW storage facility

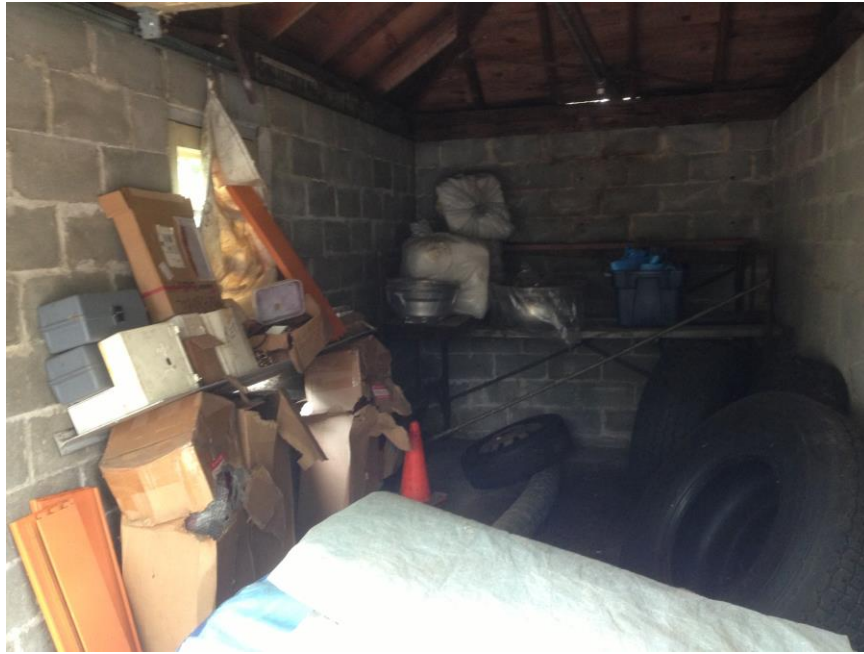
Figure 54 – Interior of Town owned storage facility near the VA Hospital
